# National Transportation Safety Board Aviation Accident Final Report

<b>Location:</b>	Angel Fire, New Mexico	<b>Accident Number:</b>	WPR20FA008
<b>Date &amp; Time:</b>	October 20, 2019, 08:45 Local	<b>Registration:</b>	N7742P
<b>Aircraft:</b>	Piper PA 24	<b>Aircraft Damage:</b>	Substantial
<b>Defining Event:</b>	Collision during takeoff/land	<b>Injuries:</b>	2 Fatal
<b>Flight Conducted Under:</b>	Part 91: General aviation - Personal

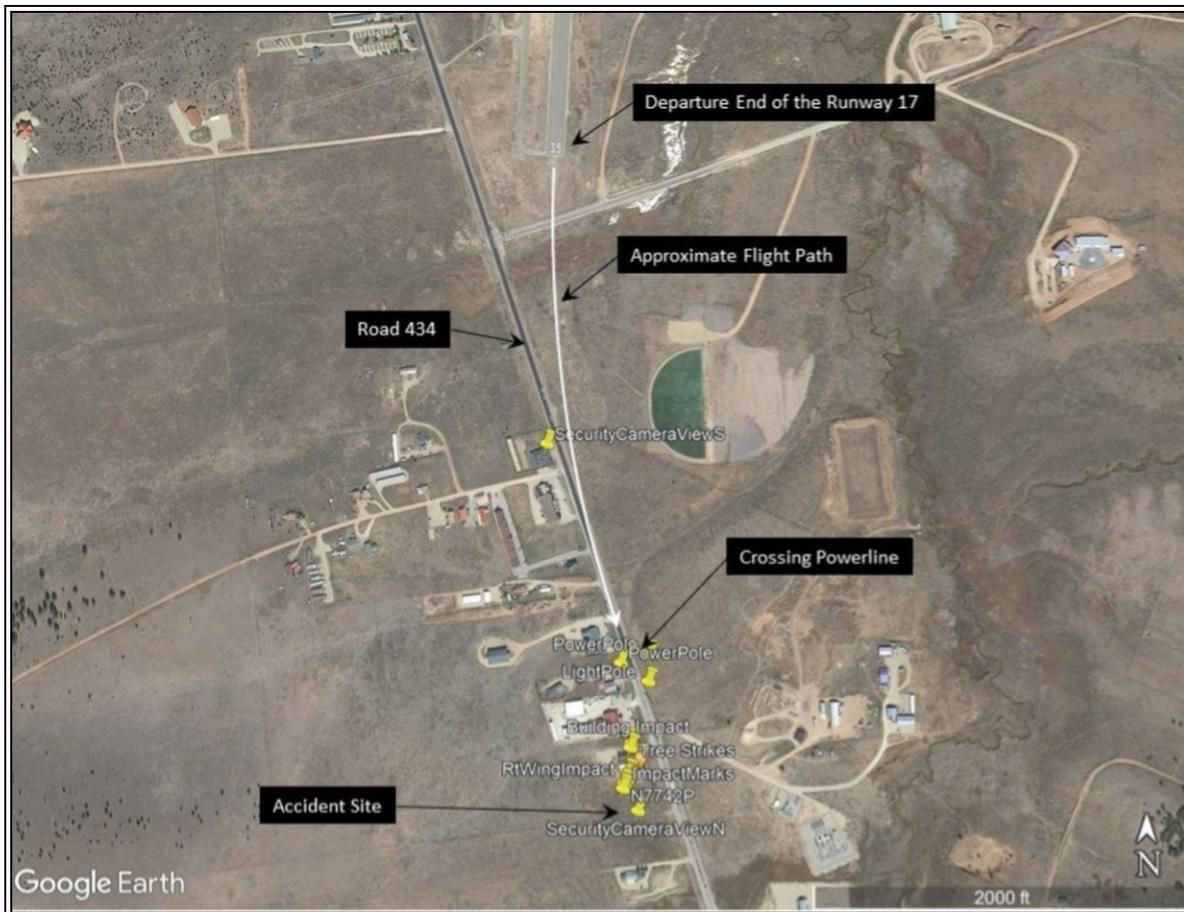
A security camera with a southward view, located at a business between the airport and the accident site, captured the airplane flying overhead about 50 ft above ground level, over the adjacent road. The airplane was flying wings level and the landing gear was extended. As the airplane approached the light poles and power lines in the background, the airplane banked right and traveled behind trees and buildings until it went out of view. Another security camera located near the accident site captured the airplane impacting trees and a building, before cartwheeling to the ground in a nose-down attitude. The airplane's engine was heard producing power in the video. The airplane came to rest in an inverted position and a postaccident fire ensued.

Figure 1-Aerial view of the accident site and approximate flight path.
