# Engine malfunction involving Cessna 441, VH-JFU

100 km north-east of Tindal Airport, Northern Territory, on 7 September 2021

**ATSB Transport Safety Report**

AO-2021-039

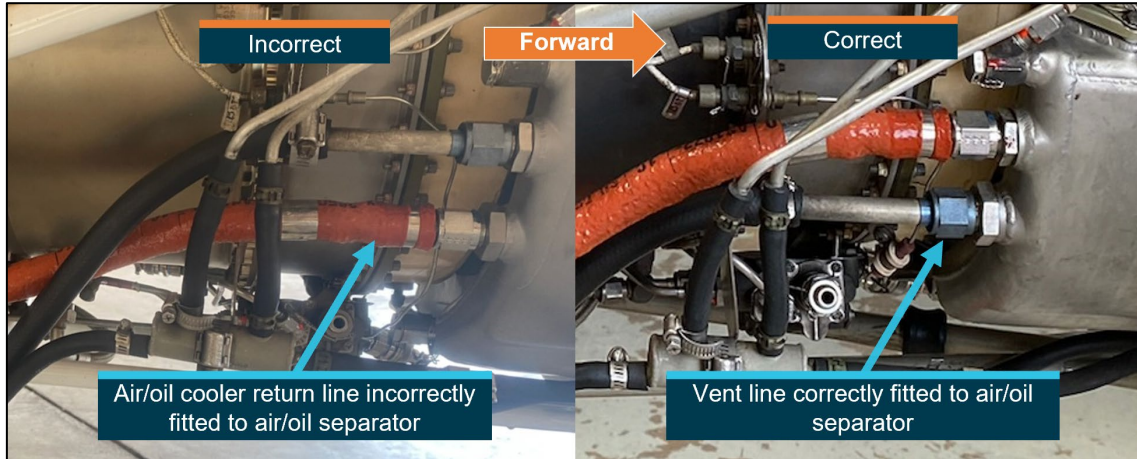
**Figure 1: Oil tank fittings as found**

At Tindal, it was identified that the air/oil cooler return line and the air/oil separator vent line had been transposed (each incorrectly fitted to the wrong part of the oil tank) when fitted to the oil tank (Figure 1).

When the right engine was fitted to VH-JFU, the air/oil cooler return and the air/oil separator vent lines were incorrectly transposed. The airframe and engine maintenance manuals correctly showed the orientation of the air/oil cooler return and the air/oil separator vent lines. Accordingly, there was sufficient accurate information available for engineers to be aware of the possibility of inadvertent oil line transposition.

- During the installation of the right engine, the oil cooler return line and the air/oil separator outlet line were transposed when attached to the oil tank.
- The oil cooler return and the air/oil separator outlet flexible lines could be easily transposed given that their fittings were adjacent to each other, of the same size, and visually similar. Additionally, as occurred in this case, their markings on the oil tank could wear off in service.

Following consultation with an engine overhaul organisation, the air/oil separator was changed, and the engine oil was checked for contamination. After the oil lines were correctly assembled, an engine run was carried out and no further defects were identified. The aircraft was released to service.

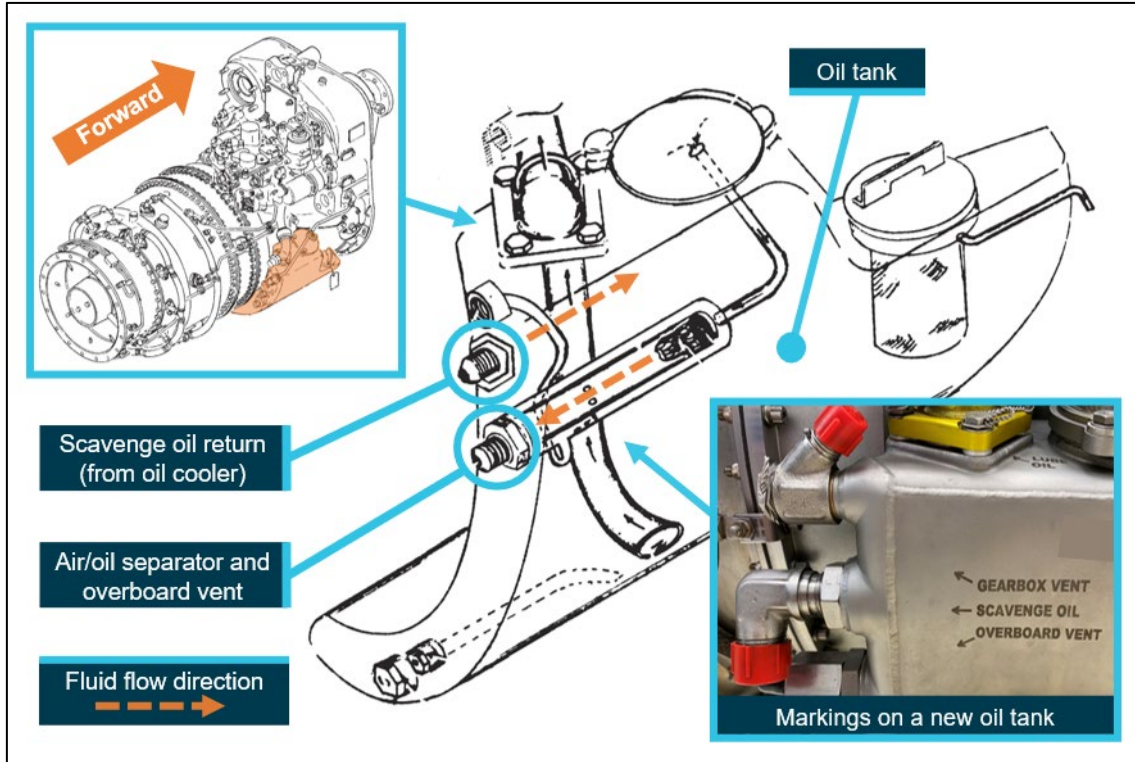
**Figure 2: TPE331 oil tank assembly**

The externally-mounted engine oil tank incorporated 2 adjacent fittings that were almost identical in appearance, were the same size, and used the same thread (Figure 2). These 2 fittings included:

- an upper fitting for oil returning to the tank from the air/oil cooler
- a lower fitting for an overboard vent line from the air/oil separator.

The fittings were labelled, but the markings were anecdotally reported to wear off in-service (Figure 2). These markings were not present on VH-JFU's right engine at the time of the engine change.

The manufacturer had implemented controls that would help prevent this error occurring. These included markings showing the correct position of the lines, but they could wear off in service. The markings were not present on VH-JFU’s engine oil tank at the time of the maintenance error and therefore there was no prompt to check the correct fitment. As a result, there would have been no clear indications of which way around the 2 lines should be fitted, and there was a risk of inadvertent transposition.

- commenced a fleet-wide program to apply markings to the oil tanks on its Cessna 441 fleet
- conducted toolbox talks with engineering staff
- expanded the maintenance log entry requirements for engine changes.

On 18 August 2022, Honeywell (the engine manufacturer) reissued service information letter (SIL) P331-115 about the potential transposition of the oil lines with additional information and guidance. Specifically, the manufacturer provided a template for the reapplication of the oil tank markings. It also noted:

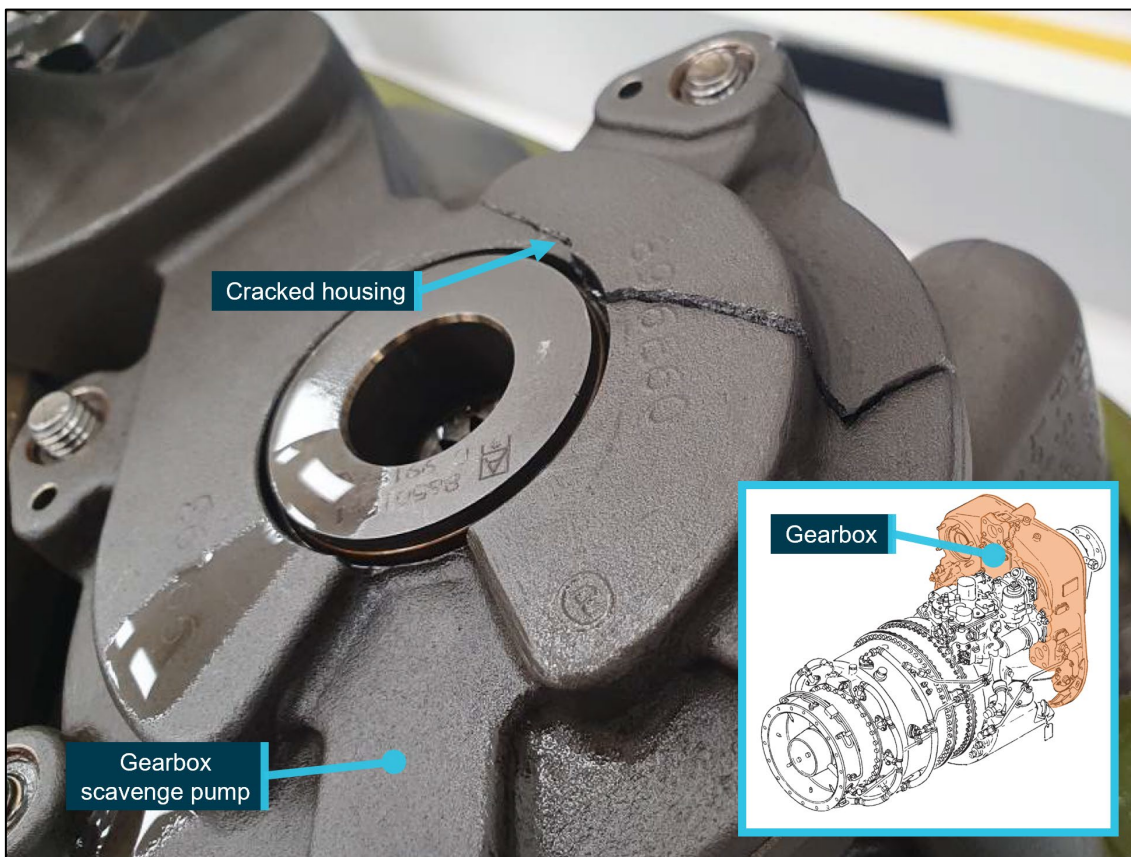
**Figure 3: Cracked reduction gearbox scavenge pump housing**

The engine manufacturer advised that flow reversal from the incorrect fitment of the air/oil cooler return line to the air/oil separator would have compacted the Teflon<sup>3</sup> ribbons inside the air/oil separator.

The engine was removed and sent to an overhaul facility. The engine was disassembled and the reduction gearbox scavenge pump housing was found to be cracked (Figure 3). The engine manufacturer advised the ATSB that the Teflon ribbons would have been compacted inside the air/oil separator following incorrect fitment of the air/oil cooler return line. This would have increased the reduction gearbox scavenge pump pressure and compromised the structural integrity of the pump housing.

- When the oil lines were returned to the correct position, the damage to the reduction gearbox scavenge pump housing was not detected and the aircraft was returned to service.
