NATIONAL TRANSPORTATION SAFETY BOARD
Office of Research and Engineering
Washington, D.C. 20594

Video Study

NTSB Case Number:
WPR18FA013

Location: Four Corners, California
Date: October 21, 2017
Time: 1612 PDT
Aircraft: Extra EA 300/L

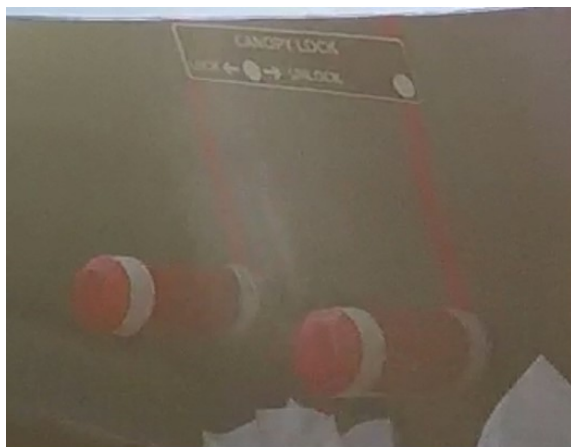
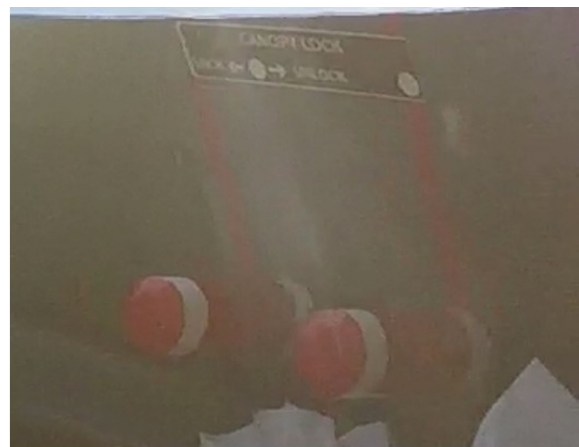
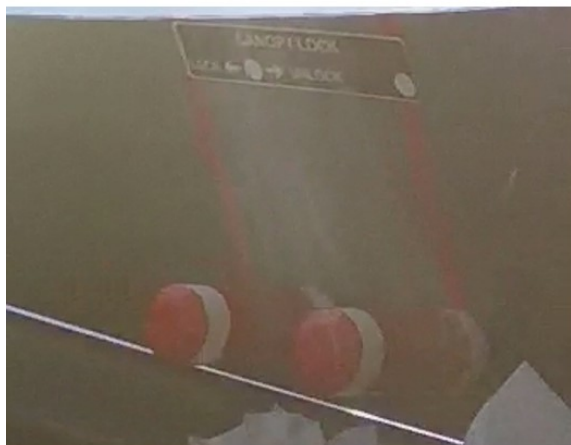
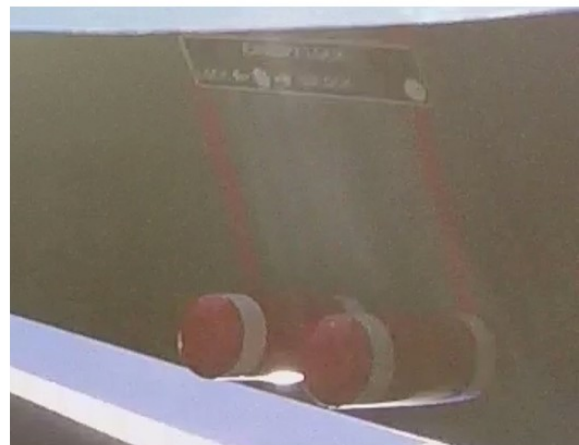
Figure 2. Positions of Forward Canopy Locking Pin

At time 6:33.16, the forward (next to the passenger) canopy locking pin is still seen in the Lock position, as shown in Figure 2a. At time 6:33.23, the locking pin is seen closer to the Unlock position, as seen in Figure 2b. At time 6:33.26, the locking pin is in the

Unlock position and the canopy starts opening. At time 6:33.29, the canopy is on its way toward being fully open, as seen in Figure 2d.

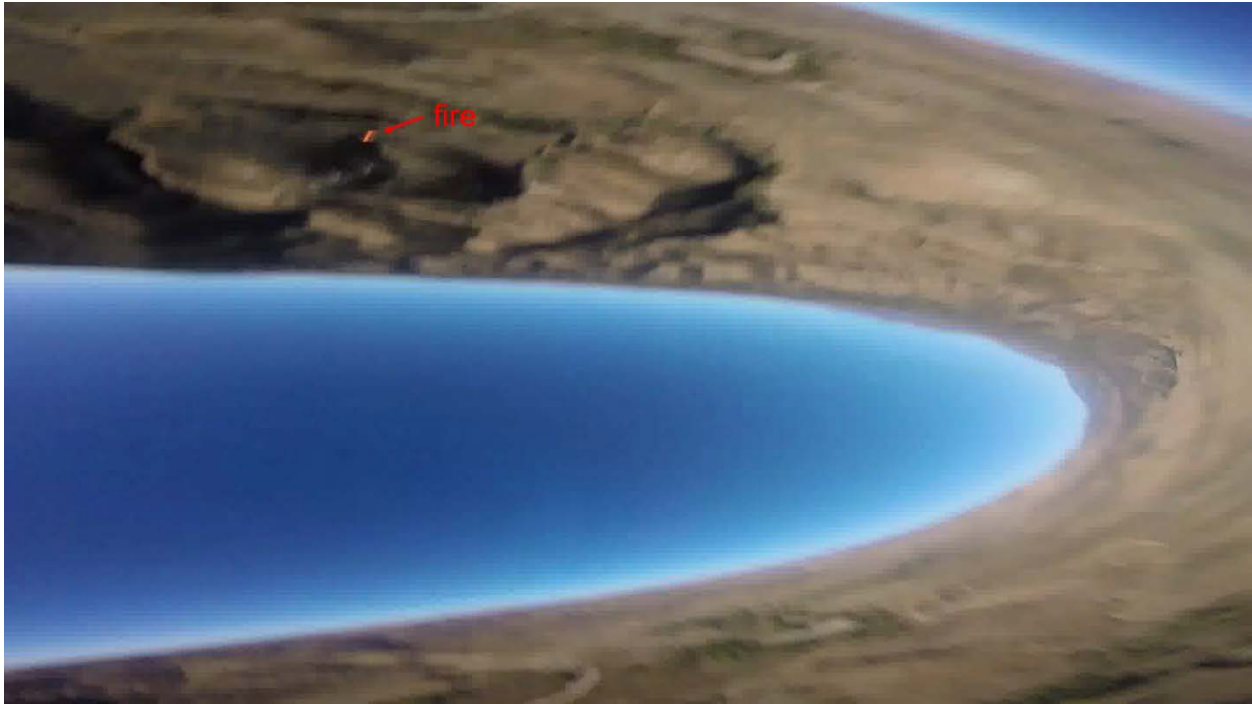
Figure 3. Video Frame Showing Fire at the Crash Location (Time: 6:39.32)

Past video time 6:33.63, the camera was spinning while it was falling toward the ground, as is evident in the ground images that the camera recorded. At video time 6:39.32, the camera recorded a video frame shown in Figure 3. It shows fire at the location where the airplane impacted the ground. The shape of the fire in the figure is due to the high speed of the falling camera. Figure 4 shows the crash location at video time 6:54.39. Both fire and smoke are visible in the video frame.

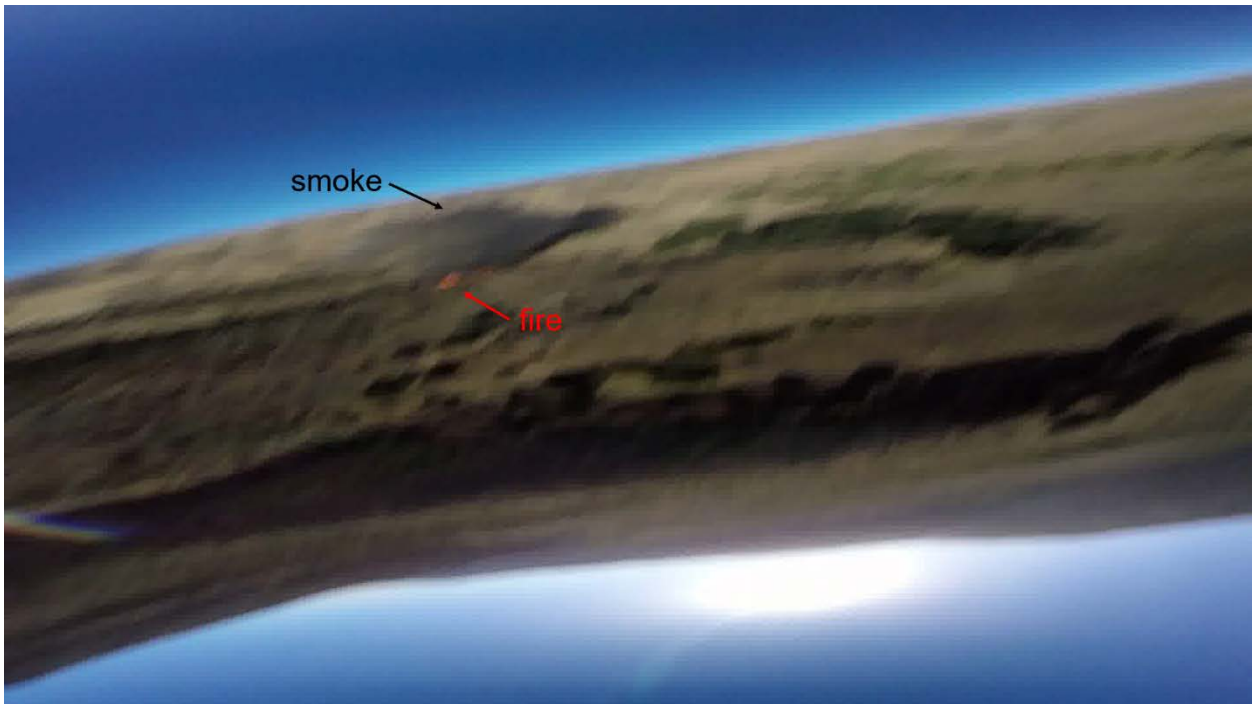
Figure 4. Video Frame Showing Smoke at the Crash Location (Time: 6:54.39)

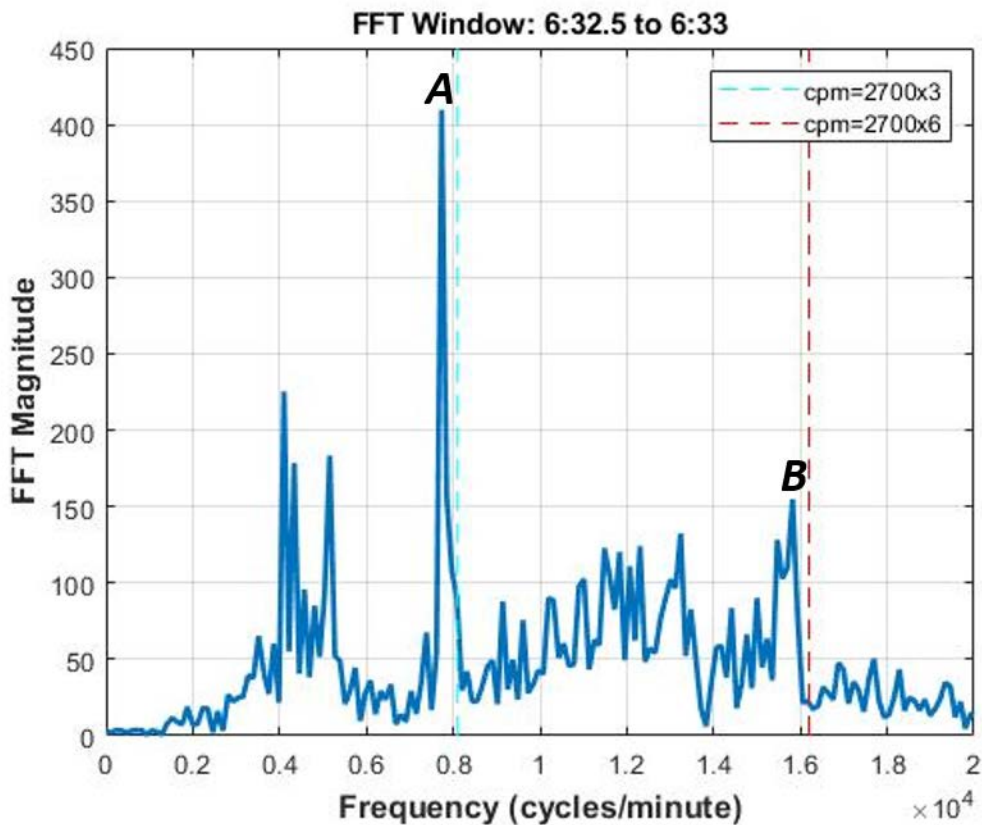
Figure 5. Sound Spectrum before the Canopy Opened

The video included a sound channel that was sampled at 48kHz. Sound spectrum analysis was performed on 0.5-seconds-long samples using a fast Fourier transform (FFT). Figure 5 shows the magnitude of the FFT transform of the sound between time 6:32.50 and time 6:33.00, i.e., just before the canopy started opening. The rated speed of the Lycoming AEIO-580-B1A engine is 2700 RPM. The airplane propeller had three blades. Therefore, the blade passage frequency of 2700×3 cycles per minute and its second harmonic, at 2700×6 cycles per minute, are marked in the figure.

Spectral peak *A*, just to the left of the 2700×3 line, indicates that the engine speed was about 2580 RPM, slightly below the rated speed. Spectral peak *B*, just to the left of the 2700×6 line, is the second harmonic of the blade passage frequency and/or sound emitted by the 6-cylinder engine.
