Aviation Investigation Final Report

Location:	Hertford, North Carolina	**Accident Number:**	ERA17MA316
Date & Time:	September 8, 2017, 11:20 Local	**Registration:**	N146DU
Aircraft:	EUROCOPTER DEUTSCHLAND GMBH MBB BK 117	**Aircraft Damage:**	Destroyed
Defining Event:	Loss of engine power (partial)	**Injuries:**	4 Fatal
Flight Conducted Under:	Part 135: Air taxi & commuter - Non-scheduled - Air Medical (Discretionary)

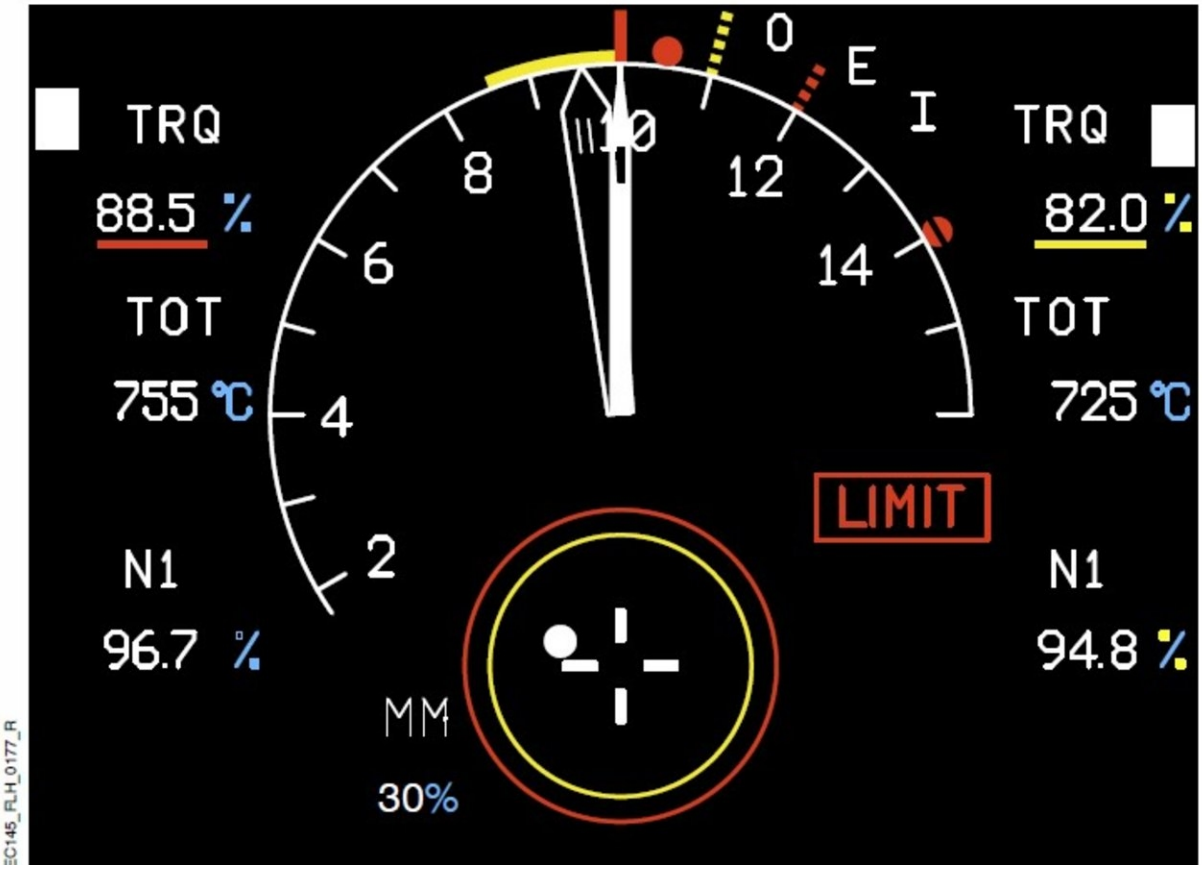
Figure 1 - First limit indicator. (Information from rotorcraft flight manual.)

The needles can represent TRQ, TOT, or N1, depending on which of these parameters is the closest to its operating limitation for each engine given the conditions at the time. For example, during cruise flight on the day of the accident, the needle for each engine (operating normally) would have corresponded to torque. In normal operation, both engines would have also remained torque matched by an automated variable rotorspeed and torque matching system (VARTOMS). In this case, the "first limit" for both engines would be torque. The first limiting parameter is the parameter that is closest to its limit and does not mean that parameter has reached a limit. For example, as the pilot adds power, the engines would eventually reach one of the torque operating limits before reaching any of the turbine outlet temperature or gas generator speed limits. In different ambient conditions, such as operation at higher pressure altitudes, the first limiting parameter can instead be N1. Normally, both engines are limited by the same parameter.

The needles do not depict the value of the first-limited parameter (the scale inside the arc, numbered 2 through 14 in figure 1, is unitless, and standardized for comparison of the three limiting parameters) but rather the relationship of the parameter to several different limits that are shown on the outside of the arc as colored lines and symbols. These limits, including those for the OEI condition, are always displayed. The digital numeric values arranged vertically on the left side of the display show the values of TRQ, TOT, and N1 for the No. 1 engine; the numbers on the right side show the values for the No. 2 engine. These numbers, and the white boxes showing which parameter is currently closest to a limit for each engine, are also always displayed.

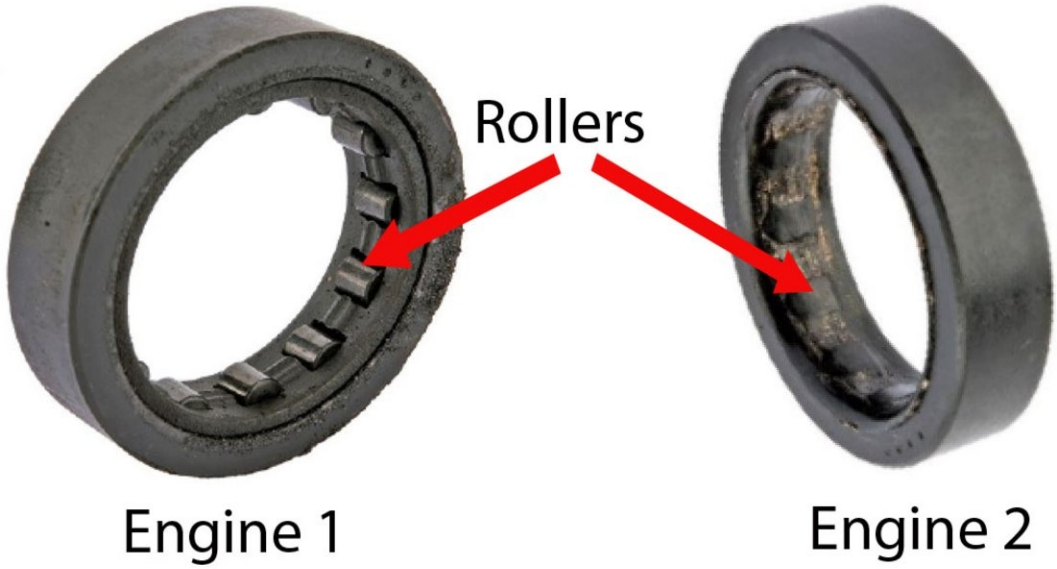
Figure 2 - Gas generator shaft rear bearings.

Detailed examination of the No. 2 engine revealed that its gas generator shaft rear bearing was seized and damaged. Specifically, all the roller elements were flattened and none of the roller elements would rotate. Several bearing components showed damage consistent with friction between the seized rollers and the inner race and ensuing overheating. These signatures were not observed in the No. 1 engine gas generator shaft rear bearing. The lack of rotation of the roller pins and the damage to the gas generator spool indicated that the No. 2 engine's rear bearing had failed during the accident flight.

The No. 2 engine disassembly revealed that the gas generator shaft rear bearing was mechanically damaged. A detailed examination of the bearing at the engine manufacturer's laboratory revealed that all of the bearing roller elements were found seized (that is, none of the roller elements would rotate), with the outer bearing race, and had rubbed against the inner rotating bearing race. The roller elements appeared ground down (flattened) and overheated.

Figure 2 compares the No. 2 engine rear bearing with the undamaged No. 1 engine rear bearing. Turbine components and the end of the No. 2 engine gas generator shaft exhibited rotational non-uniform damage. This damage was consistent with some continued rotation of the gas generator spool after the bearing had seized. (The turbine shaft supported by the rear bearing rotates at speeds up to 53,500 rpm.)

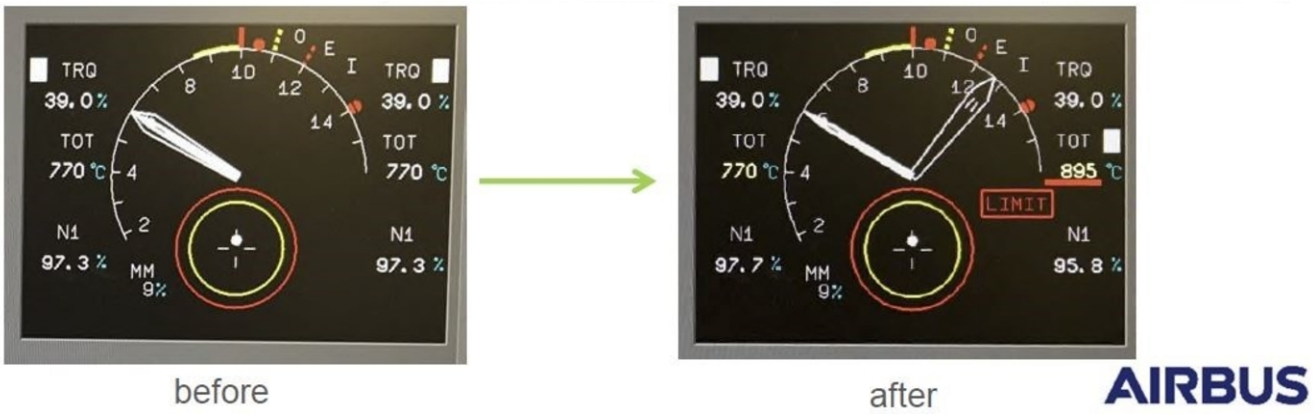
Figure 3 - Simulated FLI display before and during rear bearing seizure.

Specifically, as the bearing failed, the FLI needle for the No. 2 engine would have changed from indicating torque (TRQ), to indicating turbine outlet temperature (TOT) due to a sudden rise in TOT in the No. 2 engine. Such a switch would have been unusual, because the needles normally reflect TOT during engine start only. The change in the position of the No. 2 FLI needle would have resulted in a large split between both needles.

The left image of figure 3 shows the FLI with the engine operating normally, prior to a bearing seizure. Both FLI needles should depict TRQ because that would be the first limiting parameter for both engines in the flight conditions on the day of the accident. The needles would both indicate the same or nearly the same value for TRQ because both engines should produce about the same power, as the engines are TRQ balanced by the VARTOMS system. The simulation showed that, with a rear bearing seizure in the No. 2 engine, the engine's turbine outlet temperature would be elevated such that the TOT limit would be reached before the torque limit. Thus, an elevated turbine outlet temperature would result in the FLI changing to TOT for the No. 2 engine, as denoted by the white box for the No. 2 engine moving from the TRQ label (in the left image) to the TOT label (in the right image) and the position of the needle for the No. 2 engine changing. In addition, because TOT reached its limit, the digital value appeared with a red bar underneath it. The No. 1 engine would remain limited by TRQ, as indicated by the white box for the No. 1 engine next to the TRQ label (in the right image). As a result, a large split in the needles would occur because they would no longer indicate the same parameter for each engine, even though both engines would still be initially producing the same torque (39% in the figure).

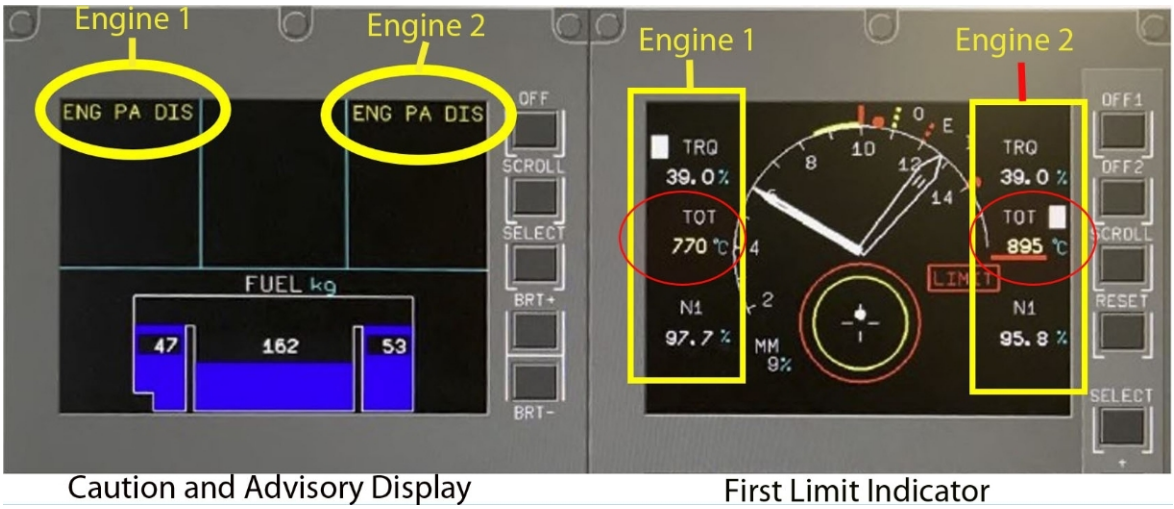
Figure 4 - Caution and advisory display panel (left) and FLI (right) showing affected engine and parameter.

The simulation also showed that an ENG PA DIS amber caution message may appear for both engines on the caution and advisory display panel, as shown in the left image of figure 4, due to the difference in TOT between engine Nos. 1 and 2. The ENG PA DIS caution message is displayed whenever a significant difference between each engine's TOT, TRQ, or N1 is detected, or when the signal from any of these parameters is lost. For TOT, the threshold to trigger the ENG PA DIS caution is a difference of greater that 80° C between engine 1 and engine 2. Even though the ENG PA DIS message appears in both engine columns on the CAD display, the CAD display does not indicate which parameter was detected or which engine was affected. As a result, the pilot would need to refer to the FLI parameters to determine which engine is affected, as shown in the right image of Figure 4. Figure 4 shows the TOT on the right engine is the limiting parameter, and during the event, it was likely to have appeared in the right (engine 2) column of the CAD (note that the "ENG CHIP" caution activation was not part of the simulation, and is not displayed in the figure). The FLM procedure for the ENG PA DIS message is "do not try and match needles, avoid using maximum power, compare the numeric values on the FLI to verify the affected parameter, and land as soon as practicable." The ENG PA DIS procedures do not request the pilot to shut down the engine.
