Loss of Pitch Control During Takeoff
Air Midwest Flight 5481
Raytheon (Beechcraft) 1900D, N233YV
Charlotte, North Carolina
January 8, 2003

Aircraft Accident Report

NTSB/AAR-04/01

National Transportation Safety Board
Washington, D.C.

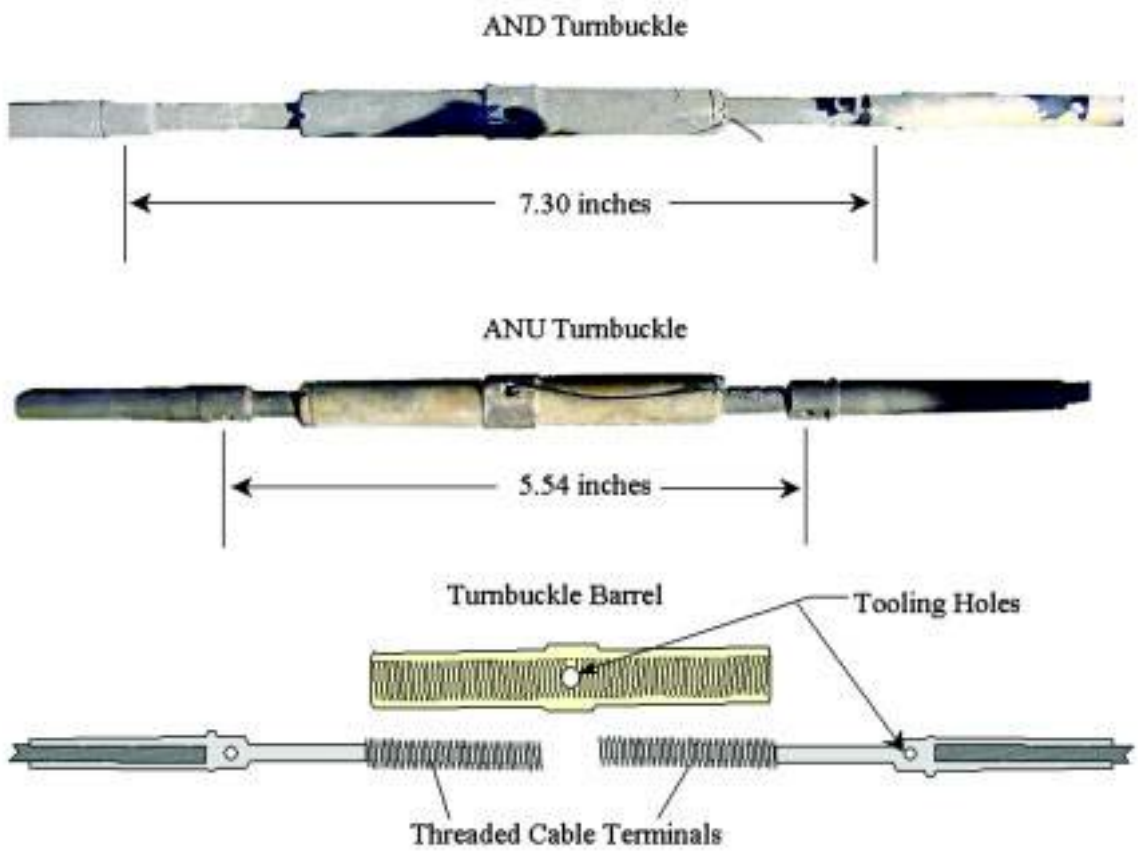
Figure 6. Turnbuckles as found in the wreckage.

The ANU turnbuckle was almost fully contracted, and the AND turnbuckle was almost fully extended. The measurement from the center of the tooling hole in one threaded cable terminal to the center of the tooling hole in the other cable terminal was 5.54 inches for the ANU turnbuckle and 7.30 inches for the AND turnbuckle. In addition, the AND turnbuckle had one thread visible, and the ANU turnbuckle did not have any threads visible. Figure 6 shows the turnbuckles as found in the wreckage and a drawing that shows a turnbuckle barrel and threaded cable terminals.

The AND turnbuckle was extended 1.76 inches more than the ANU turnbuckle. After the accident, Air Midwest surveyed its entire fleet of 42 Beech 1900D airplanes, which represented 25 percent of the 164 Beech 1900D airplanes active in the North American fleet. Air Midwest data submitted to the Safety Board indicated that, on average, the AND turnbuckle was extended 0.04 inch less than the ANU turnbuckle.

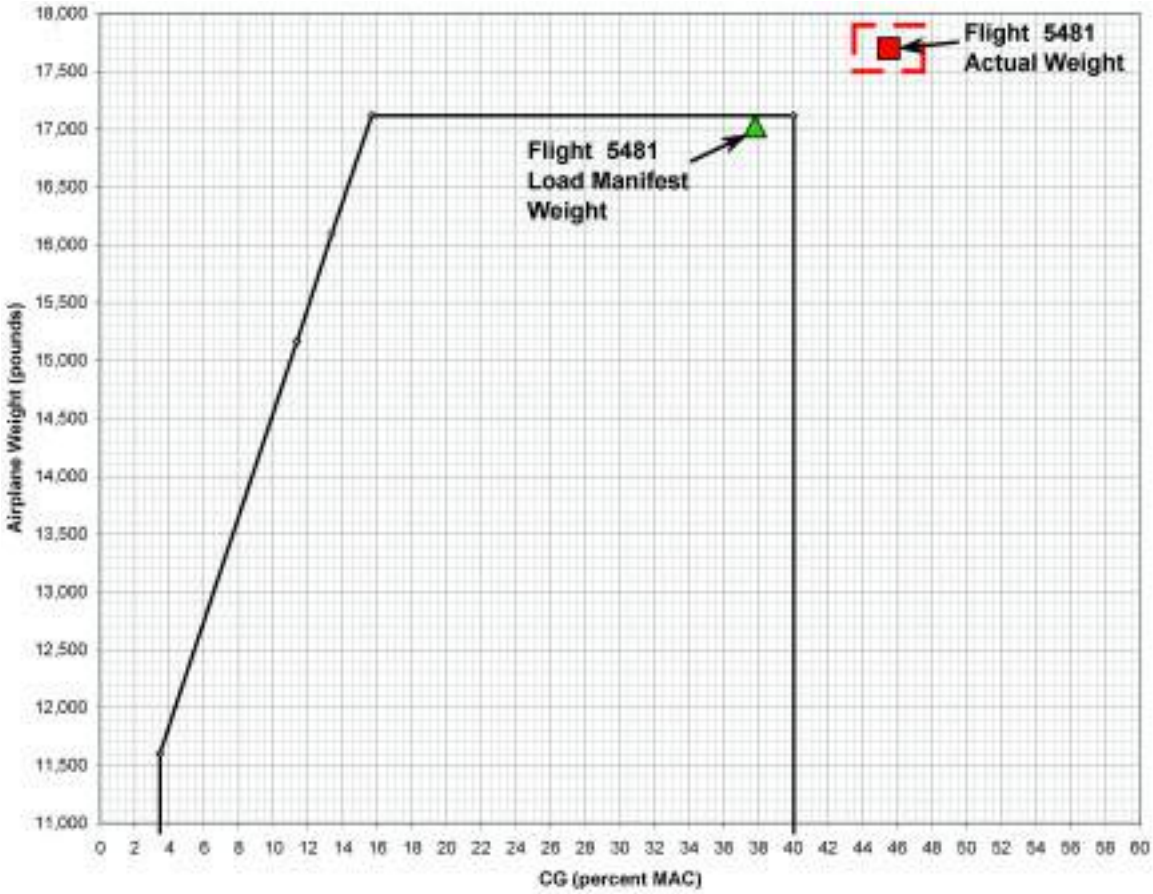
Figure 7. Weight and center of gravity information for flight 5481.

On the basis of these FDR data, radar data, the validated force and moment model, and component weight and location information, the Safety Board determined that the accident airplane had an actual weight of 17,700 ±200 pounds and an actual CG position of 45.5 ±2 percent MAC. Figure 7 shows the results of the Board's calculations overlaid on the Beech 1900D weight and CG envelope.

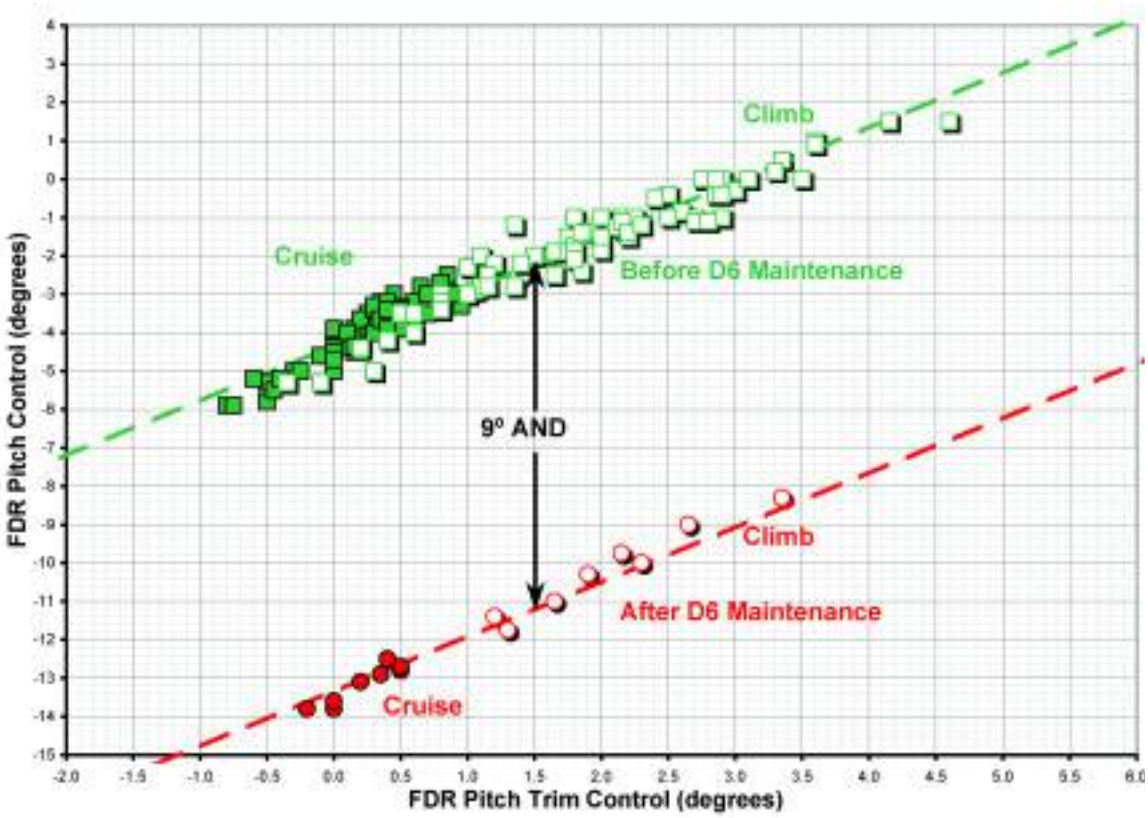
Figure 8. Flight data recorder pitch control and pitch trim control positions.

The position of the trim tab is the predominant predictor of elevator position during climb and cruise flight. Figure 8 shows that a strong correlation exists between elevator (FDR pitch control position) and trim tab (FDR pitch trim control) data. The figure shows two distinct data groups: the larger group represents flights before the D6 maintenance check, and the smaller group represents flights after the D6 maintenance check.

The larger group of data shown in figure 8 (that is, the flights before D6 maintenance) compared well with the Beech 1900D flight test certification data, indicating that the premaintenance FDR pitch control position data represented the actual elevator position to within about 1°. However, the smaller group of data (that is, the flights

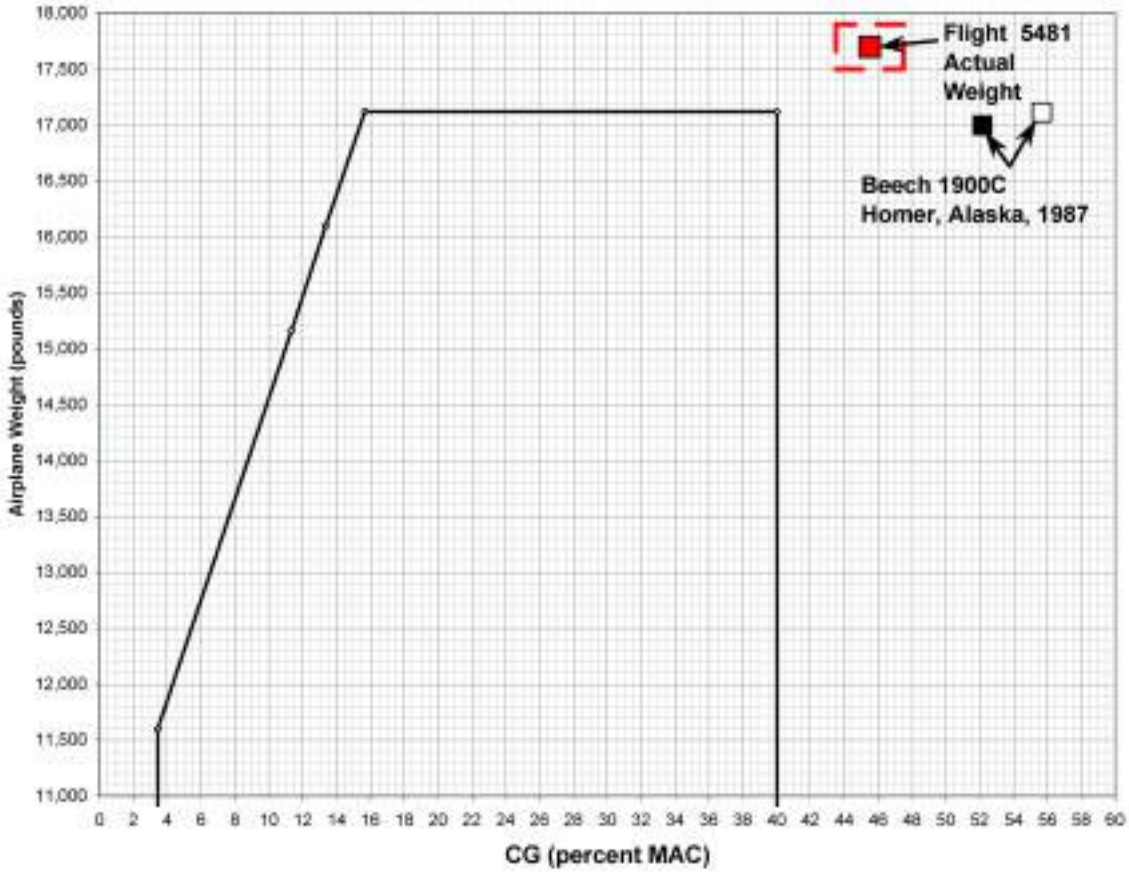
Figure 11. Flight 5481 weight and center of gravity information compared with flight 103 weight and center of gravity information.

Figure 11 shows flight 5481's weight and CG information compared with that for the flight 103 accident airplane. Two data points in the figure show the CG range for the flight 103 airplane.

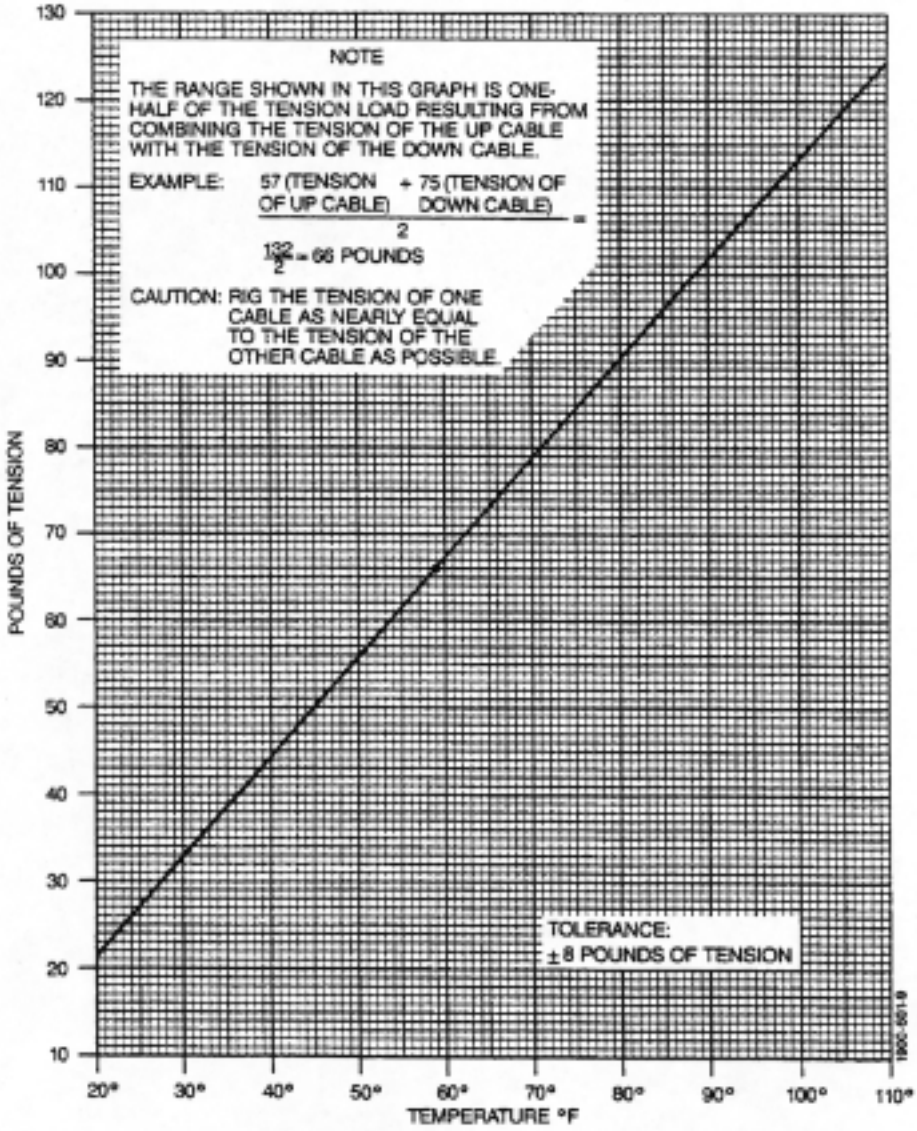
Figure 203 - Elevator Cable Tension Graph

[32] Figure 203 was an elevator cable tension graph included in section 27-30-02 of the Beech 1900D AMM. The graph did not contain instructions on how to take a temperature reading.

Regarding the Air Midwest accident, the elevator cable tension graph (figure 203) in the elevator control system rigging procedure did not contain instructions on how to take a temperature reading, which was needed to determine the tension values at which the cables should be set. Regarding the Colgan Air accident, the elevator trim system rigging procedure showed an incorrect illustration of the forward elevator trim cable drum. This error could have resulted in the incorrect installation of the elevator trim cable and elevator tab operation in the direction opposite of that commanded by the trim wheel. Regarding the CommutAir incident, the Beech 1900D AMM did not contain a procedure for replacing a thrust lever detent pin.[152]
