Engine Flameouts in Sabreliner and MU-2 Linked to Nonuse of Continuous Ignition

The flameouts occurred when the Rockwell Sabreliner encountered turbulence while being flown to cruise altitude and after the Mitsubishi MU-2 was flown through icing conditions on approach. Both aircraft struck terrain, killing the pilots.

—
FSF Editorial Staff

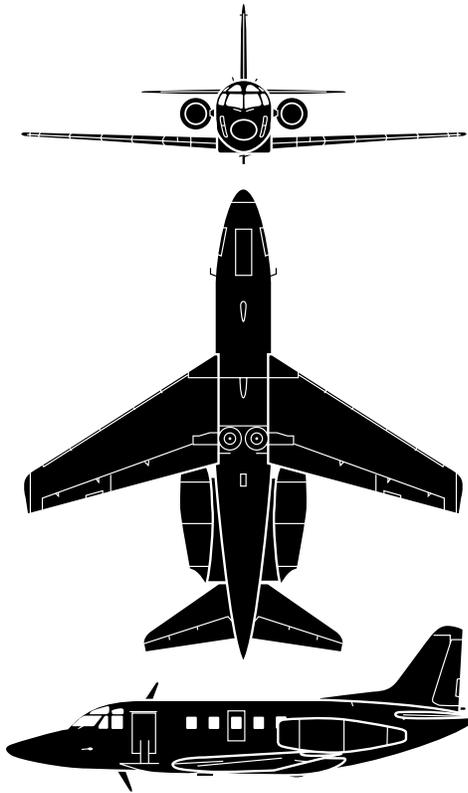
Rockwell NA-265-80 Sabreliner

North American Aviation began designing a military jet trainer and utility airplane in 1956. Production of the airplane, designated the T-39 by the U.S. Air Force, began in 1958. A civilian version, the NA-265-40 Sabreliner, was introduced in 1964. The company merged with Rockwell-Standard Corp. in 1967 to form North American Rockwell, which was renamed Rockwell International in 1973.

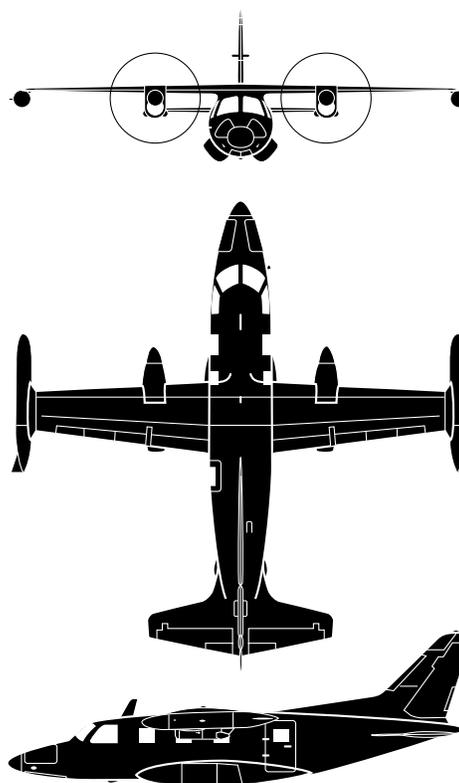
Mitsubishi MU-2B-60

Mitsubishi Heavy Industries began designing the MU-2 twin-turboprop utility transport in 1960. The MU-2A prototype first flew in 1963 with Turboméca Astazou I1K engines and three-blade propellers. Three MU-2As were built before the company changed to Garrett AiResearch (now Honeywell) TPE331-25AB engines and added three feet (one meter) to the wingspan; the revised model, the MU-2B-10, first flew in 1965. The MU-2B-20 was introduced in 1969 with 705-shaft-horsepower (526-kilowatt) TPE331-1-151A engines.
